CRANKSHAFT

SIDE CLEARANCE INSPECTION

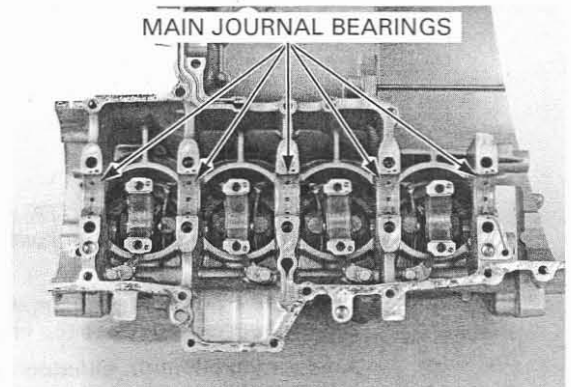
Remove the main journal bearings from both the crankcase halves.
