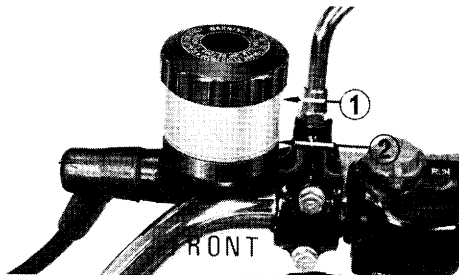
Whenever the level falls near the lower level mark (2), check the brake pads for wear. Replace the pads with new ones if necessary. After bleeding air from the system, again check to determine that the fluid level is at the upper mark. If the level is low, fill the reservoir with DOT 3 BRAKE FLUID from a sealed container, to the proper level. Reinstall the diaphragm and washer, and tighten the reservoir cap securely.

1 Upper level mark

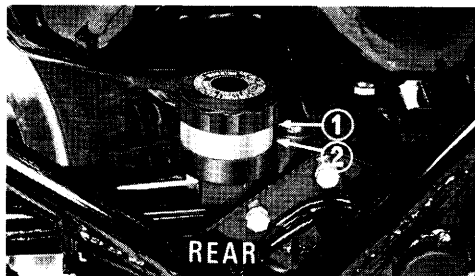
2 Lower level mark

If the brake pad wear does not exceed the limits, this will usually indicate fluid leak which should be repaired by a qualified Honda service technician. Consult nearest Honda dealer.
