## Drive chain

### Checking the drive chain for wear

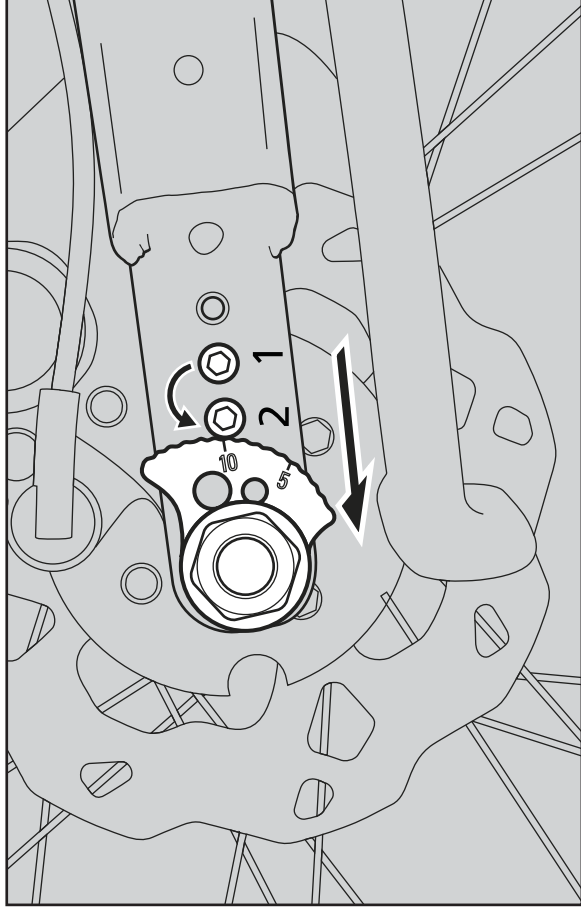
The chain is tightened using the eccentric chain adjusters. These have two different positions on the swingarm.

When it is necessary to set the eccentric chain adjuster to the maximum adjustment point (position 15) of the second position of the swingarm in order to tighten the chain, this means that the chain is excessively worn and must be replaced.
