Check the condition of the drive chain slipper and drive chain guide slider.

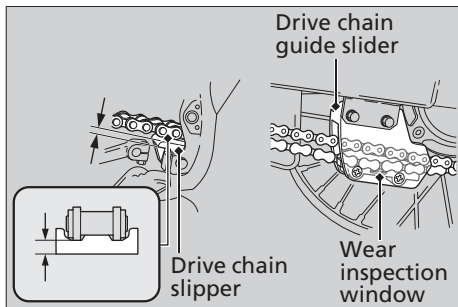
The drive chain slipper needs to be replaced if it is worn to the wear limit.

Chain slipper thickness limit:

0.08 in (2.0 mm)

The drive chain guide slider needs to be replaced if the chain is visible through the wear inspection window.

If necessary have the drive chain slipper and drive chain guide slider replaced by your dealer.
